Air Vision,

Electrical currents destroying the bearings.

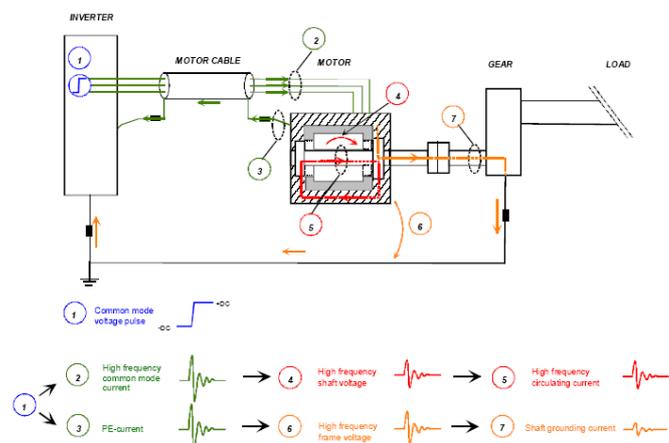
- The impedance of the return circuit currents with a variable regime has for effect to modify the voltage potential of the motor frame in regards to the neutral. If the shaft is accidentally connected to the earth via the driven machine, one part of the return current may cross through the motors house bearing, the shaft and the bearings of the driven machine (fan) to the converter. The figure above shows those two types of current.

The frequency inverter supplies the motor with high frequency voltage pulses. These create variable regime currents, which are passing through the phase wires and thanks to the parasitic capacitance of the bearings, through the motor stator. The largest part of the current goes back to the inverter via the earth cable. But a part of it is still circulating in several circuits, depending on the installation site and the type of motor manufacturing, creating damages to the bearings according two ways:

1. This current whose distribution is not uniform in the windings can produce a high induced voltage between the ends of the motor shaft. This creates therefore a high frequency current circulating in the two bearing and in the motor frame. The probability of this current birth is directly depending on the size and power motor, the voltage supplied and the switching frequency of inverter. This current is dangerous for the bearings motor of high size and it cross it with same amplitude in both bearings.

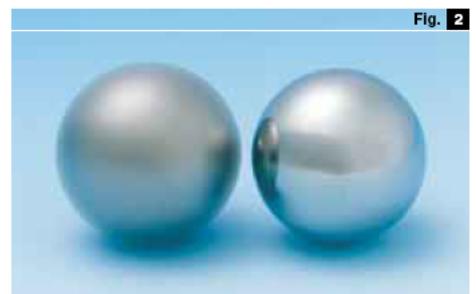
L'aspect mat de la surface de la bille signale la présence de micro-cratères

The damages involved by those currents are characterized by frost or scratched bearing tracks and by grey and dull bearing elements.

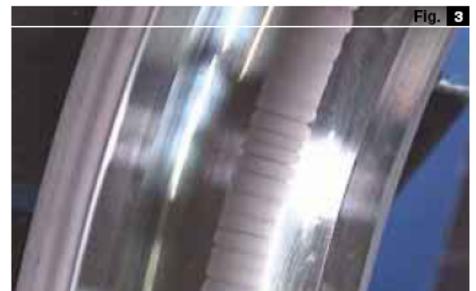
Cannelures ou ondulations sur le chemin de roulement constituant des dégradations secondaires

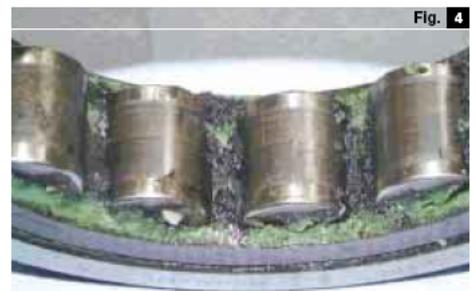
Graisse noircie par les décharges électriques à hautes fréquences
